Technical Bulletin

Boxer 4K30 Light Engine Replacement Precaution

This bulletin provides a replacement precaution for the Boxer 4K30 light engine to prevent damage from occurring to the red formatter board.

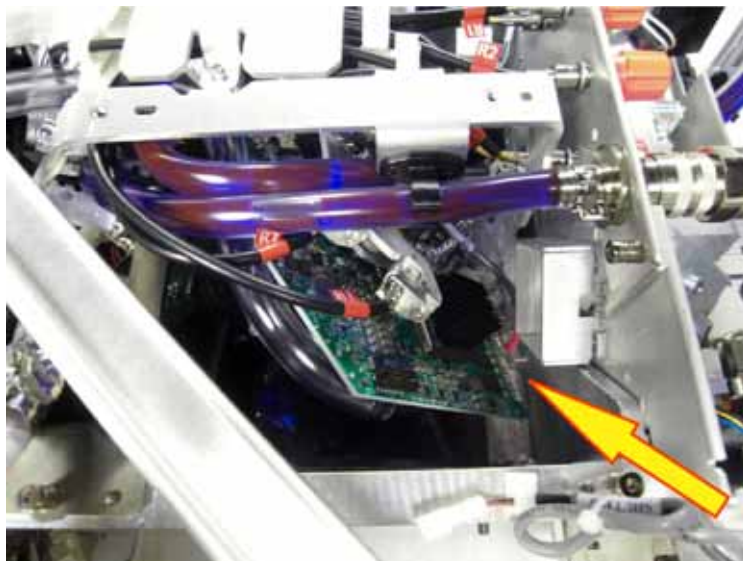
When removing or replacing the light engine, ensure special care is taken around the red formatter board and the fan duct. If you do not lift light engine straight out or replace it straight in, the formatter board may contact the fan duct, which can disable the red formatter board.
